APPENDIX 24 - Guideline on Pavement Renovation Works and Tree Stability

Guideline on Pavement Renovation Works and Tree Stability

Greening, Landscape and Tree Management Section

Development Bureau

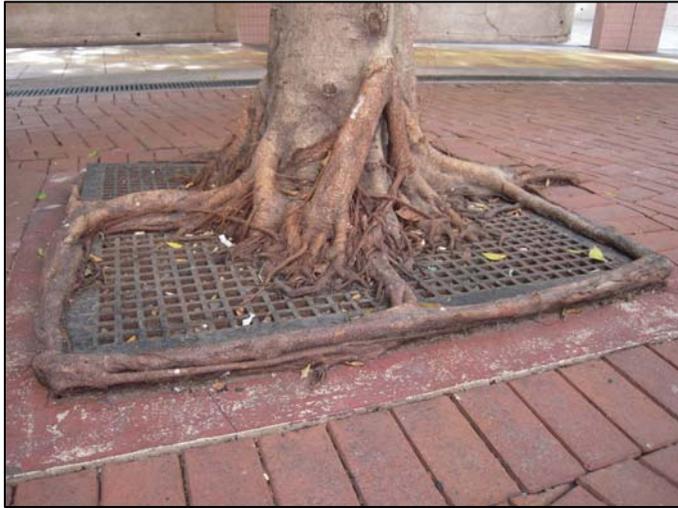
Fig. 1 The tree roots grow along hard surface

Trees are highly adaptable to the surrounding environment. When roots come in contact with a hard surface, such as a concrete footpath or kerb, they tend to grow along the hard surface and sometimes even integrate with features such as tree grilles when tree pits are not enlarged or tree grilles not removed / adjusted in a timely manner. (Fig. 1).

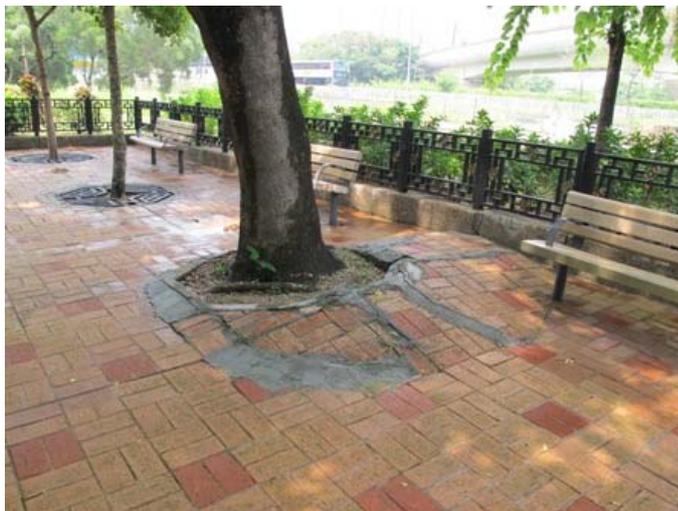
Fig. 2 Pavement lifting caused by root growth

For some tree species with aggressive roots, they may lift the paving when their roots grow under the paving (Fig. 2).

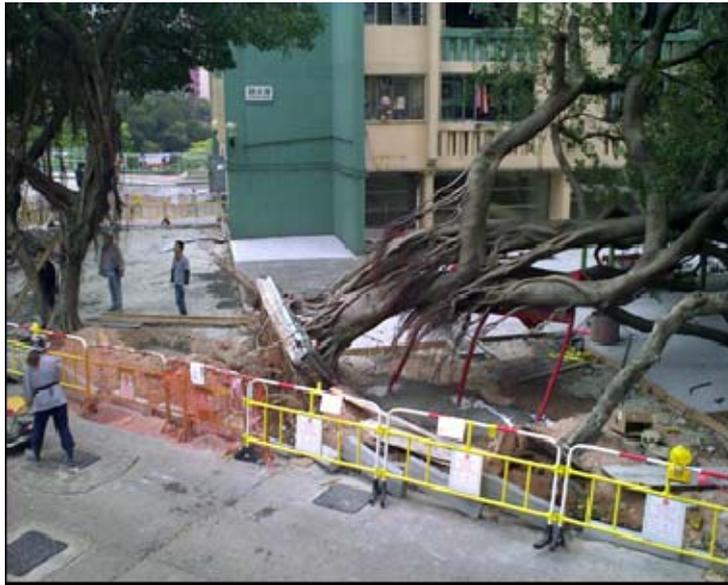
Fig. 3 *Ficus microcarpa* collapsed during repaving

A *Ficus microcarpa* (Chinese Banyan) collapsed after removing the adjacent concrete paving (Fig. 3). It was revealed that the concrete tree pit and the structural roots were bound together. There was no additional support provided to the tree before the removal of paving.

Both trees in the above cases grew in small tree pits and most roots were confined in the small, restricted growing space. The rather large trees with wide crown spread had inadequate anchorage. The concrete rims of the tree pits were held in place by the adjacent rigid concrete paving, and in turn provided support to the trees. Once the concrete paving adjacent to the trees was removed, the sudden loss of the support induced the collapse.

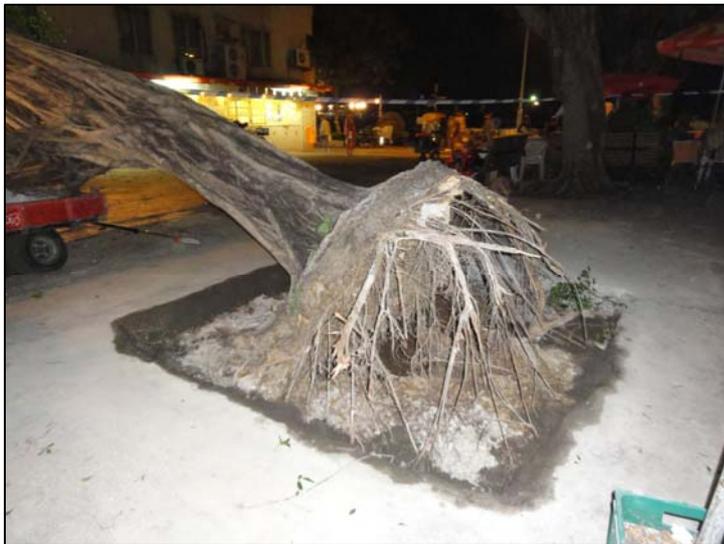
Fig. 4 *Ficus microcarpa* collapsed during tree pit enlargement works

Another *Ficus microcarpa* (Chinese Banyan) collapsed during tree pit enlargement works when the surrounding pavement around the tree pit was removed (Fig. 4).

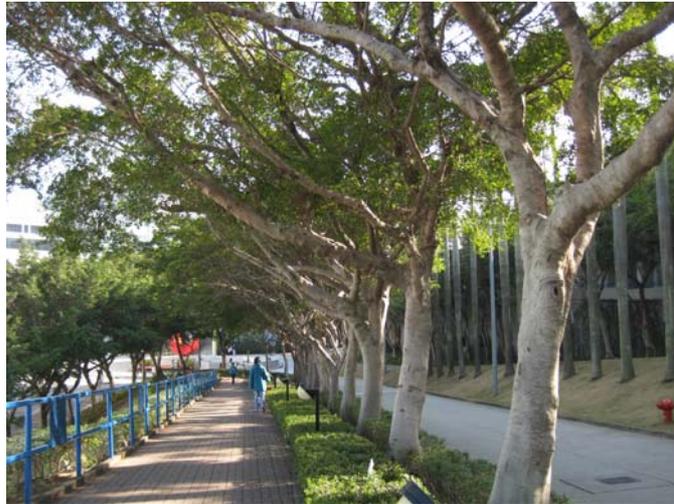
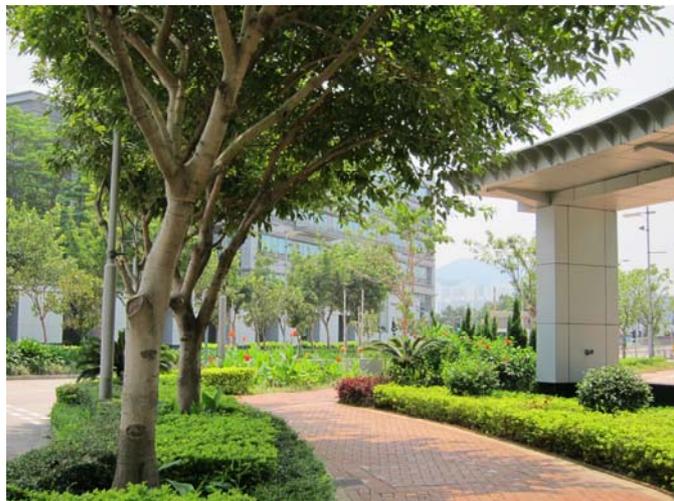
Fig. 5a & 5b Healthy tree growth in planting strips

For the healthy growth of trees in the long run, providing a planting area with sufficient space for tree roots to grow is generally preferable to growing trees in pits with limited space (Fig. 5).

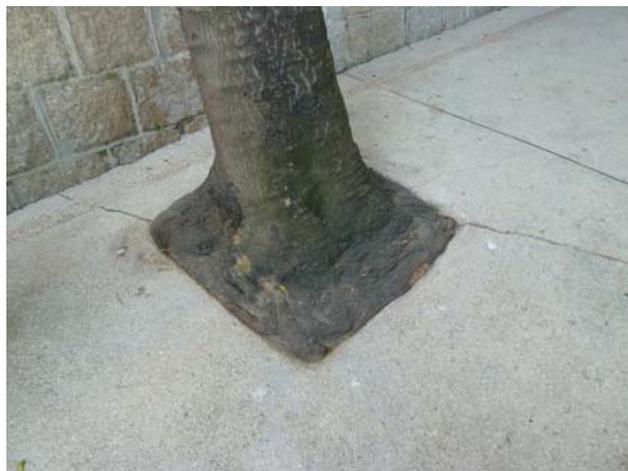
Fig. 6 A bad example showing a tree surrounded by concrete around the root collar

Adjacent paving design is also important for providing a desirable environment for tree growth, keeping the tree in good health condition, and avoiding future maintenance problems. In general, a tree should not be surrounded by concrete around the root collar (Fig. 6). Sufficient space should be allowed at the base of trees (Fig. 7). Permeable paving which allows penetration of air and water in general is recommended.

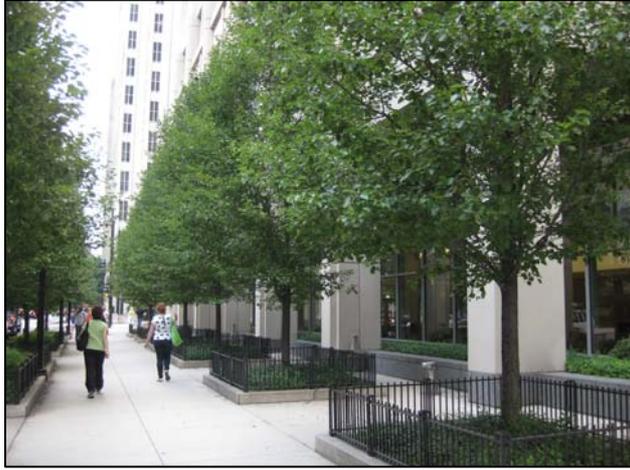
Fig. 7 Adequate unsealed space around the base of trees

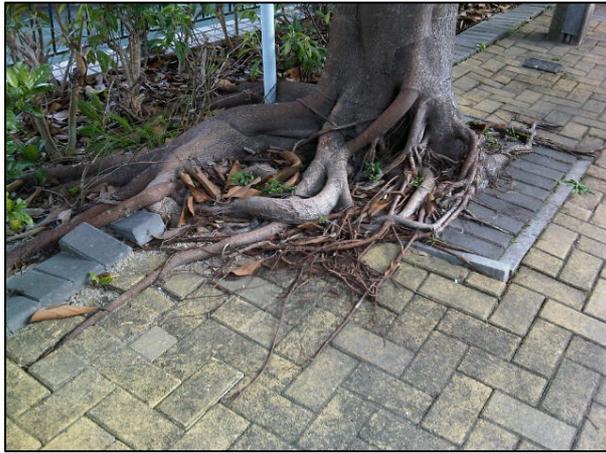
Fig. 8 Trees with aggressive roots in confined tree pits

Choosing the right tree to match a particular site is the fundamental principle of tree selection. Sufficient space both above and below ground has to be provided for the ultimate size of trees. Large canopy trees are suitable for a site that have sufficient space for the mature size of the trees and are not appropriate for narrow pavements. Trees with aggressive roots / buttress roots such as *Ficus* species are in general not suitable for planting in confined tree pits (Fig. 8) and along narrow pavements.

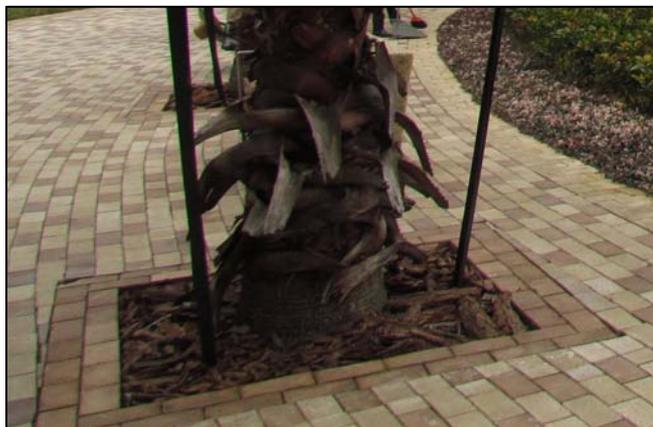
Fig. 9 Permeable paver blocks on sand base

Expandable tree grilles with adjustable panels or flexible and permeable paver blocks on sand base (Fig. 9) that can be easily removed / adjusted to allow for growth of trees should be used. They should be adjusted in a timely manner.
