New Horizon in Greening - Skyrise Greenery : **Green Roof and Vertical Greening Study in Drainage Services Department**

2 December 2010

Drainage Services Department

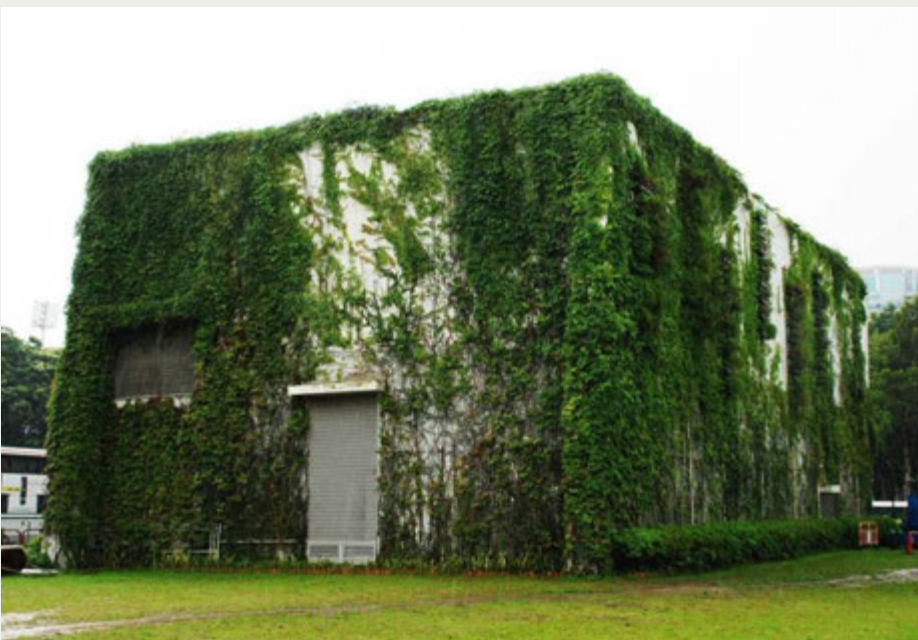
After greening

Tai Hang Tung Flood Pumping Station

- **System Adopted :**
Self-climbing vines and 12 vertical metal frames with potted planters
- **Plant Species :**
Asparagus densiflorus
'Sprengeri' (天冬),
Ficus pumila (薜荔) and
Parthenocissus himalayana
(爬牆虎)

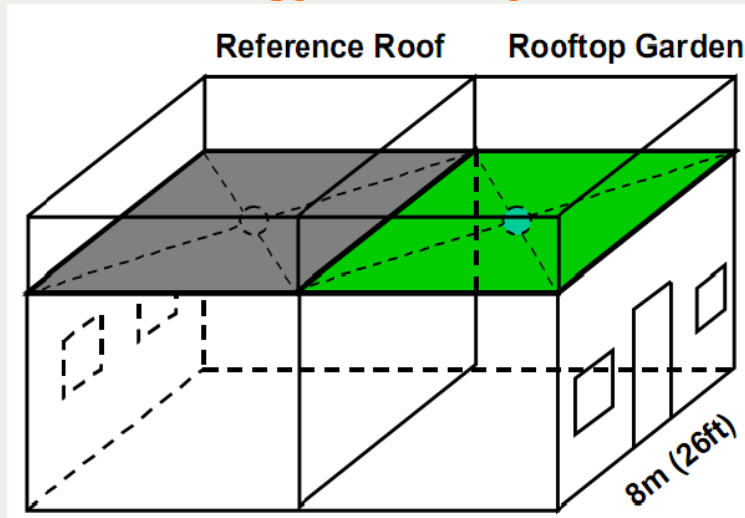
Reference Roof vs Green Roof

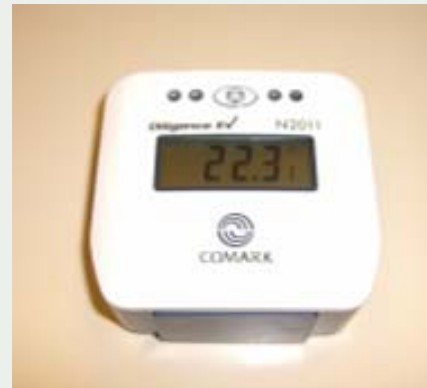
Automatic temperature logger

- Automatic temperature loggers
- Outdoor and indoor
- Summer and winter
- 5-minute intervals

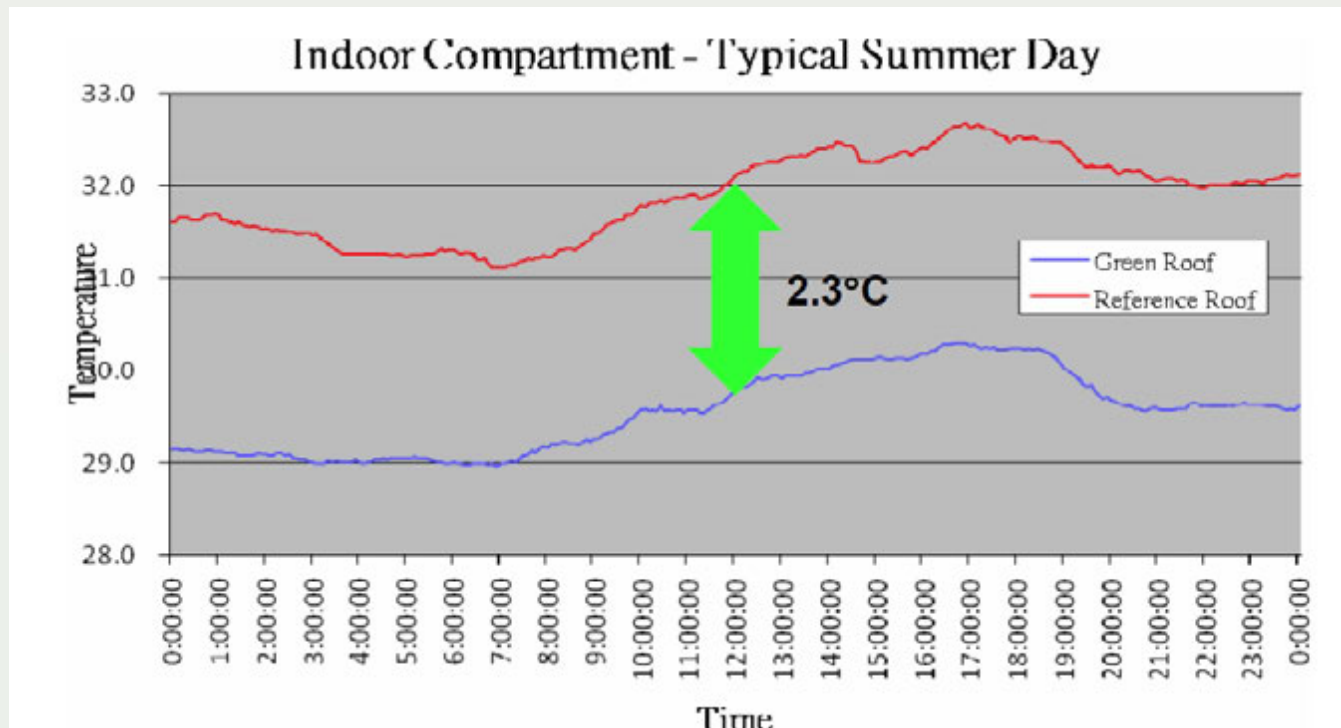
Thermal performance

1. Indoor temperature lowered by 1.5 to 2.3°C throughout the year.
2. Temperature reduction are the same to all 3 species.

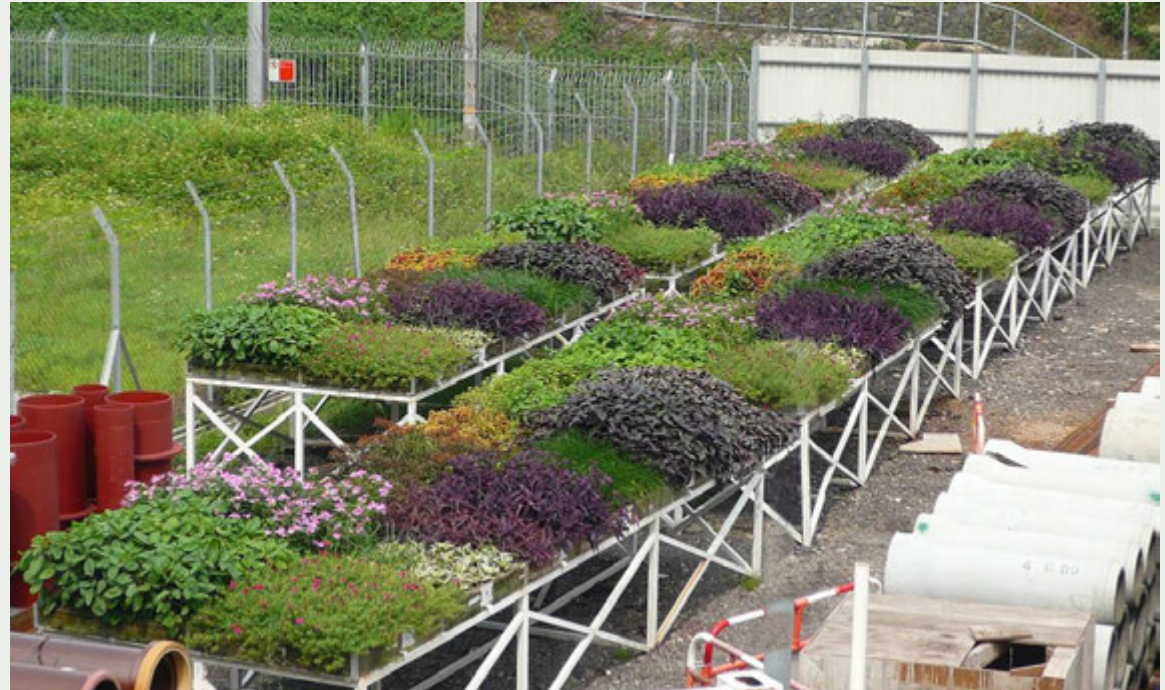
- 7 planting panels
(Size: 6m x 2m)
- Each panel with 12 planting trays
(Size: 1m x 1m)

Overview of Trial Planting

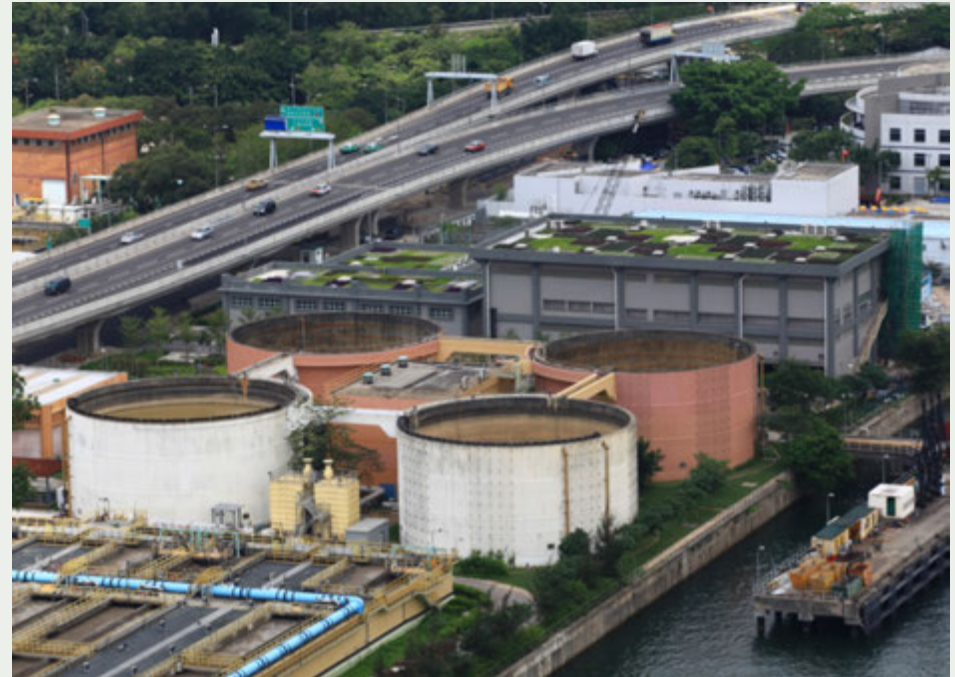
Study Site - Shatin STW

- Four circular concrete sludge tanks
- Size of tank : 27m(Dia) x 13m(H)

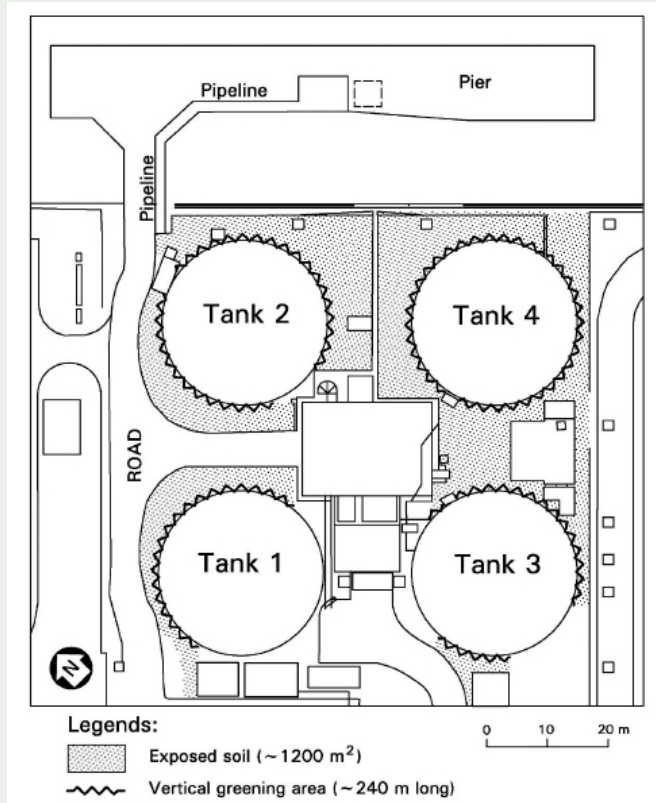
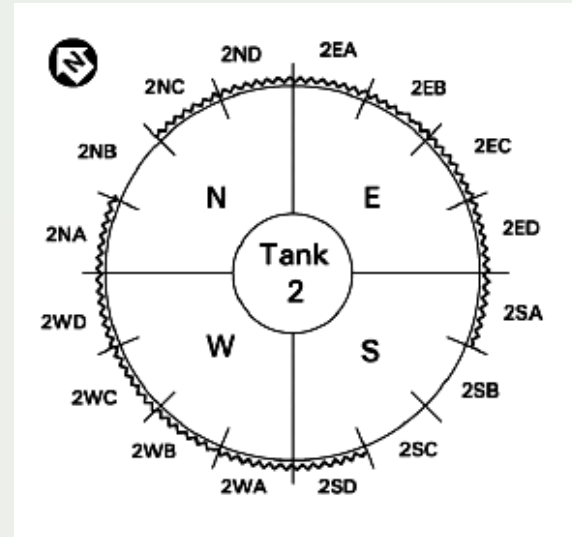
Experimental Plot : 2EA

- Each tank with four quarters (90° each) : north, east, south, and west
- Each quarter with four sectors (22.5°, 5 m wide each) : A, B, C and D
- Total 45 experimental plots

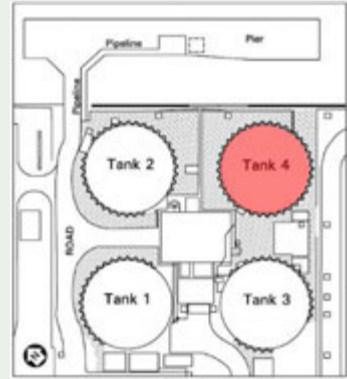
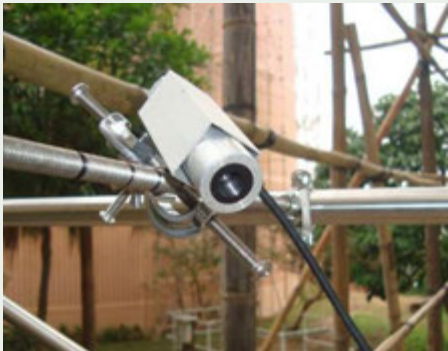
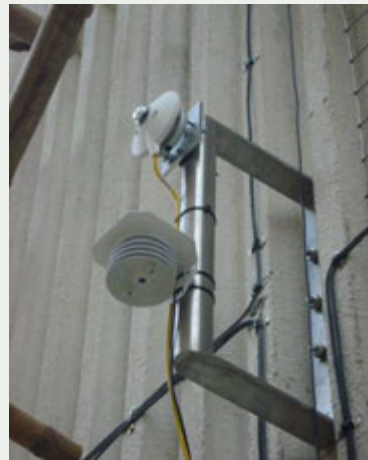
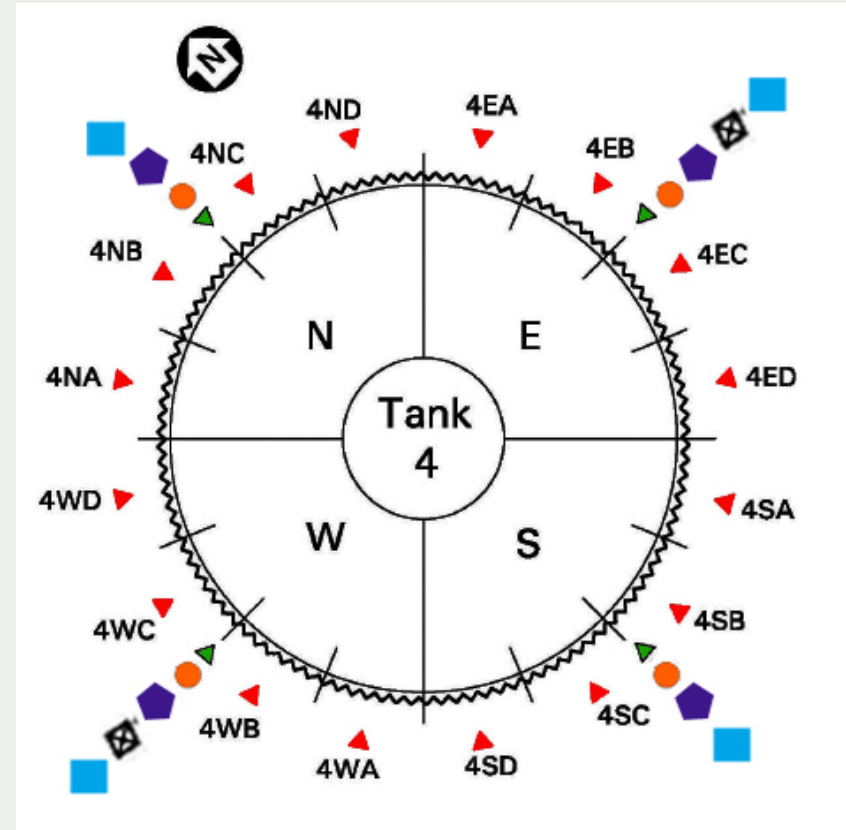
- Location : Tank 4
- Equipment installed:
 - A. Infrared temperature sensor
 - B. Solar radiation sensor
 - C. Air temperature and relative humidity sensor
 - D. Soil moisture sensor
 - E. Data logger

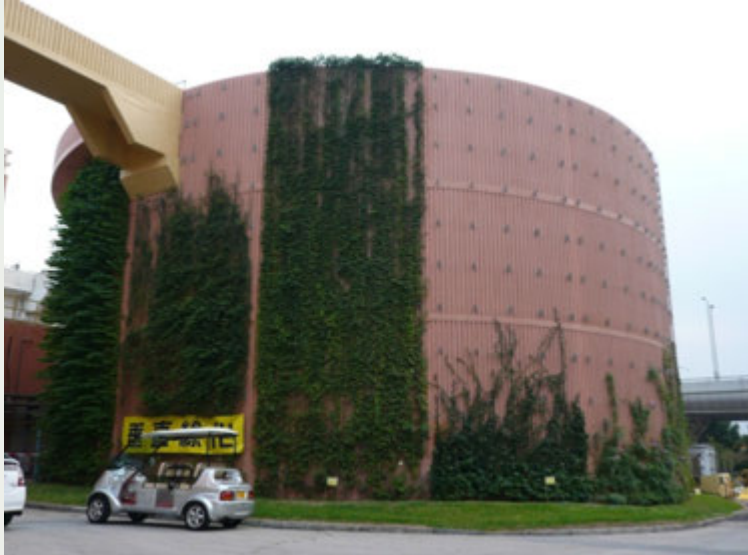
**Tank 1
(with wire meshes)**

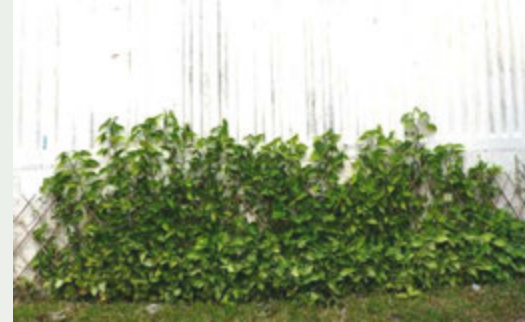
**Tank 3
(self climbing plants)**

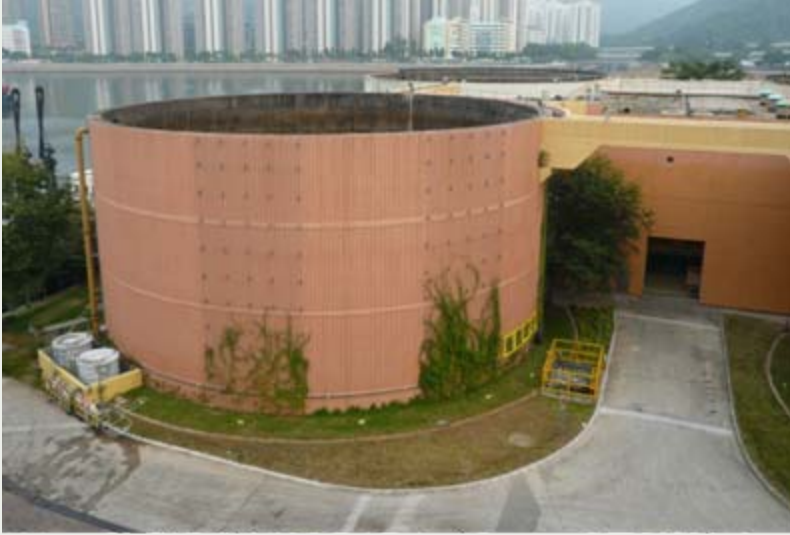
Tank 2
(testing of site factors)

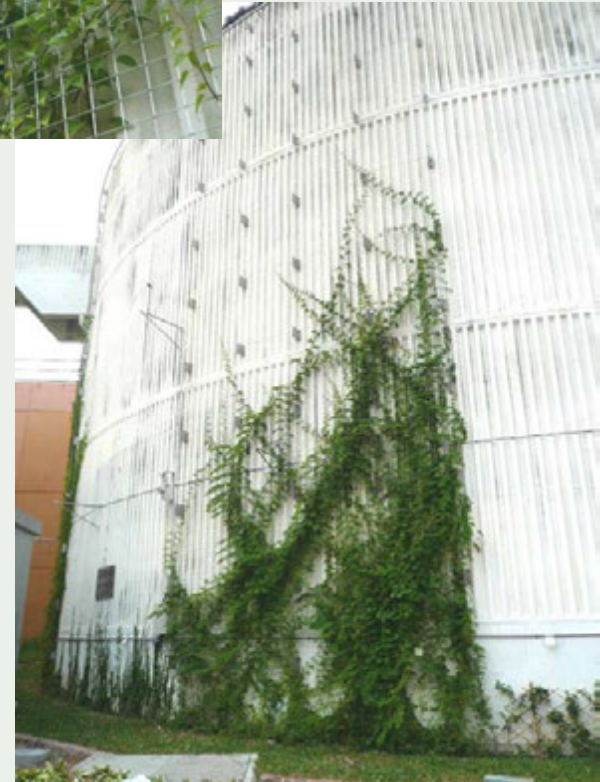
Tank 4
(testing of site factors
and monitoring of
cooling effect)
