# **Guideline on Pavement Renovation Works and Tree Stability**

**Greening, Landscape and Tree Management Section**

**Development Bureau**

**April 2013**

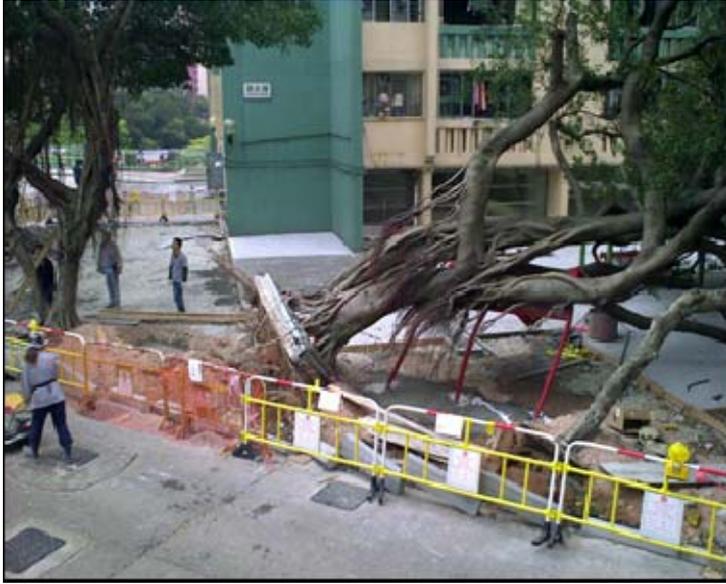
Fig. 3 *Ficus microcarpa* collapsed during repaving

A *Ficus microcarpa* (Chinese Banyan) collapsed after removing the adjacent concrete paving (Fig. 3). It was revealed that the concrete tree pit and the structural roots were bound together. There was no additional support provided to the tree before the removal of paving.

Both trees in the above cases grew in small tree pits and most roots were confined in the small, restricted growing space. The rather large trees with wide crown spread had inadequate anchorage. The concrete rims of the tree pits were held in place by the adjacent rigid concrete paving, and in turn provided support to the trees. Once the concrete paving adjacent to the trees was removed, the sudden loss of the support induced the collapse.

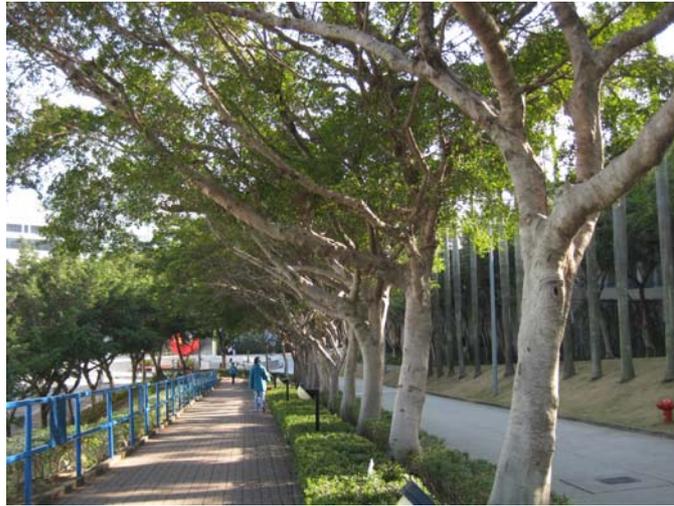
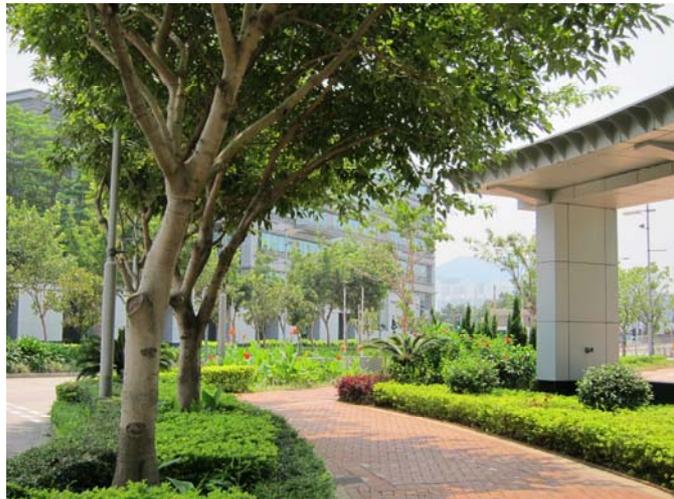
Fig. 5a & 5b Healthy tree growth in planting strips

For the healthy growth of trees in the long run, providing a planting area with sufficient space for tree roots to grow is generally preferable to growing trees in pits with limited space (Fig. 5).
