## **Management Guidelines for Stonewall Trees**

**GREENING, LANDSCAPE AND TREE MANAGEMENT SECTION  
DEVELOPMENT BUREAU**

**December 2013**

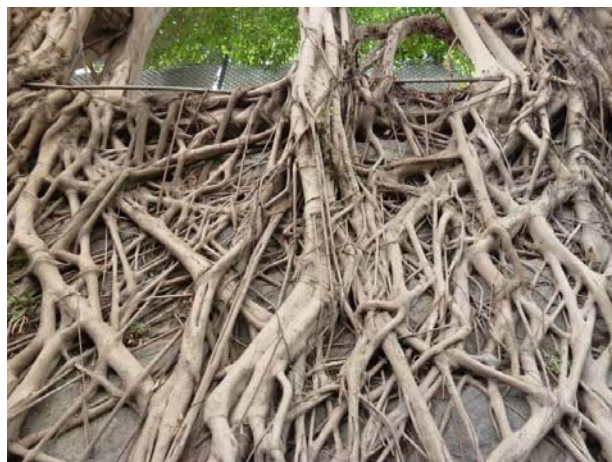
**Photo No. 1** – Distinctive root network on retaining wall surface

3.3 Roots developed on the wall surfaces also extend their colonies by sending absorbing roots to reach the soil at toe or crest of the walls to capture more water and nutrients for growth. The surface roots also fuse together at intersections to form a distinctive root network enhancing the grip on the walls. For species with aerial roots, these roots provide additional support to improve stability of stonewall trees when lignified, particularly if they can reach the soil to become prop-like supports.

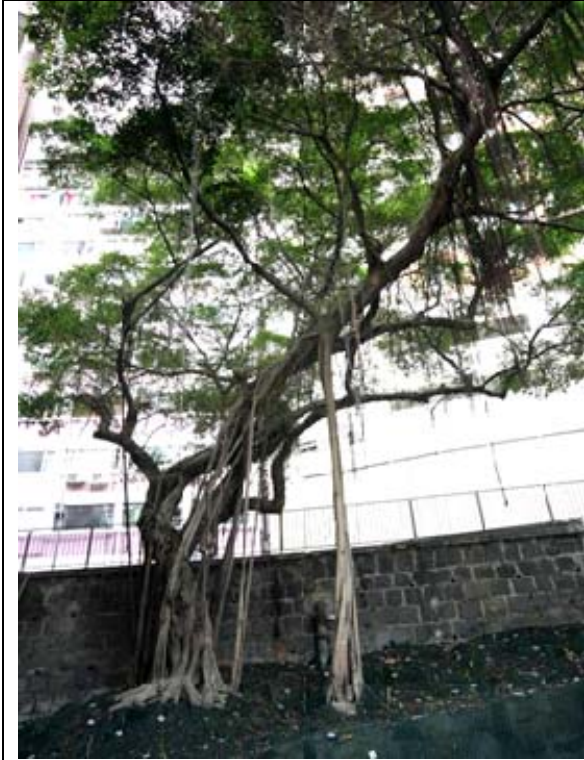
**Photo No. 2** – Lignified aerial roots forming natural prop-like supports to improve stability of stonewall tree

7.4.2 The best treatment is to allow aerial roots to reach the soil at ground to become upright lignified support for stonewall trees. If no soil is located underneath the aerial roots, opening up of paving to allow aerial roots to anchor at the ground with soil should be considered. At the same time, it would be necessary to consider the adequate strength of the whole root system to support the increased canopy size and the proportionate growth of the aerial roots to form a prop-like support. Guide tubes or ushering ropes can be used to facilitate aerial roots to reach the ground/soil quickly. If these measures are not feasible, aerial roots can be guided and ushered along branches by ropes made of degradable materials to locations for landing and anchorage. Where soil is not available in the vicinity, aerial roots can be ushered along branches to the main stems or scaffold branches to form lignified support to reinforce the branch structure. Aerial roots should be retained whenever practicable. Trimming, cutting or twisting around branches should not be allowed. Keeping joints of masonry walls unsealed is important for the root growth.

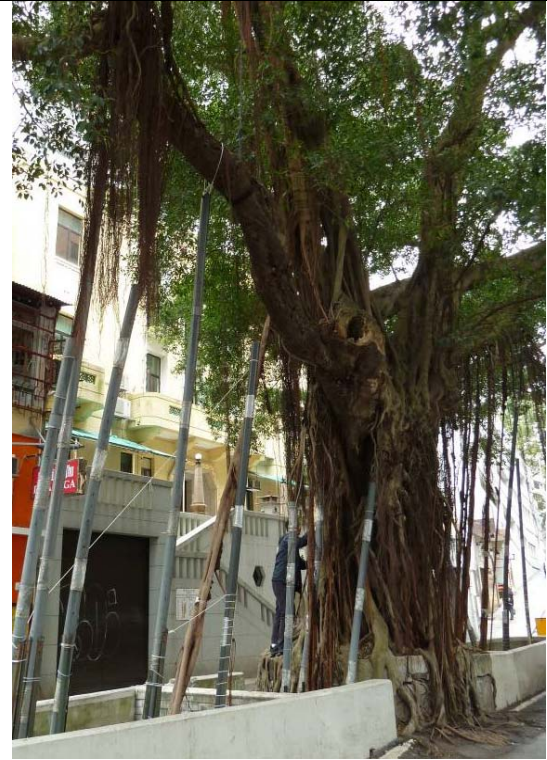
**Photo No. 3** – An example of guiding aerial roots by plastic tubes filled with planting medium

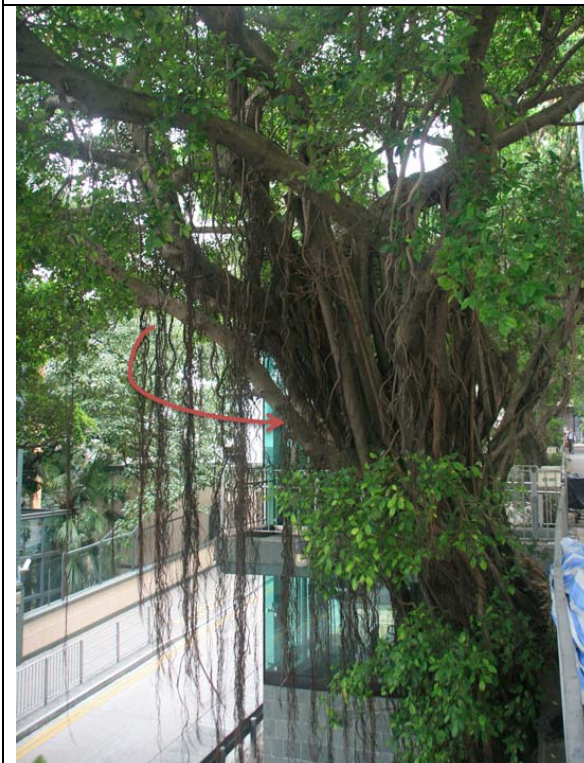
**Photo No. 4** – Aerial roots ushered along branches to the main stems or scaffold branches to form lignified support

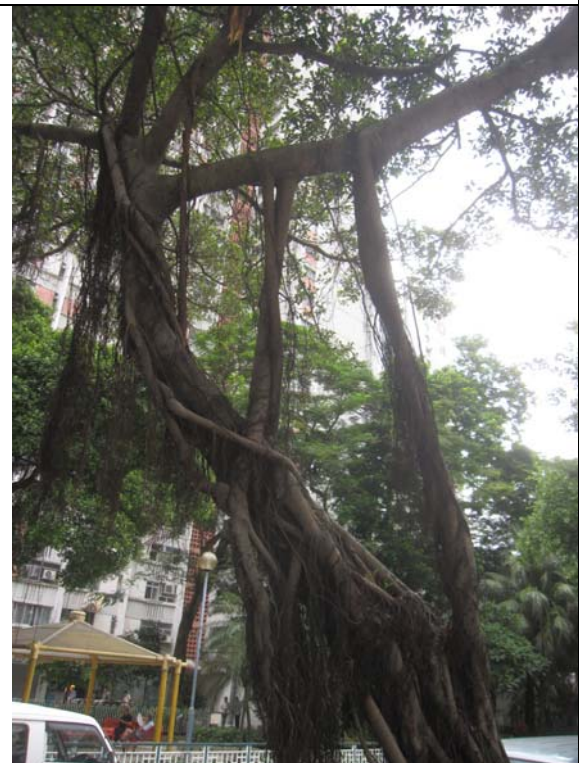
**Photo No. 5** – Aerial roots forming lignified support to strength the branch support structure

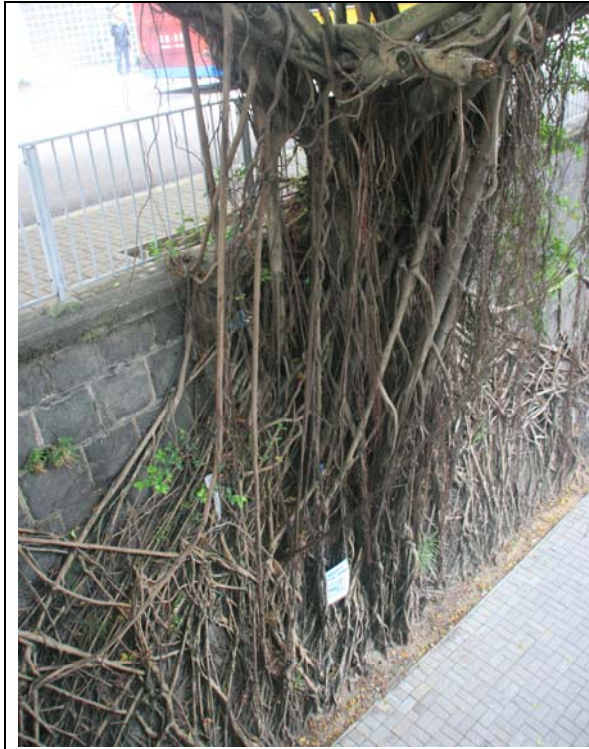
**Photo No. 6** – Provision of rooting areas at the toe of the retaining wall

Paved areas should be opened up where practicable by creating rooting areas at toe and crest of retaining walls, as it can improve water and nutrient supply and thus encourage root growth which will as a result provide extra physical support to the stonewall trees. Therefore, there should be no sealing of joints unnecessarily and in particular, at the toe of walls.

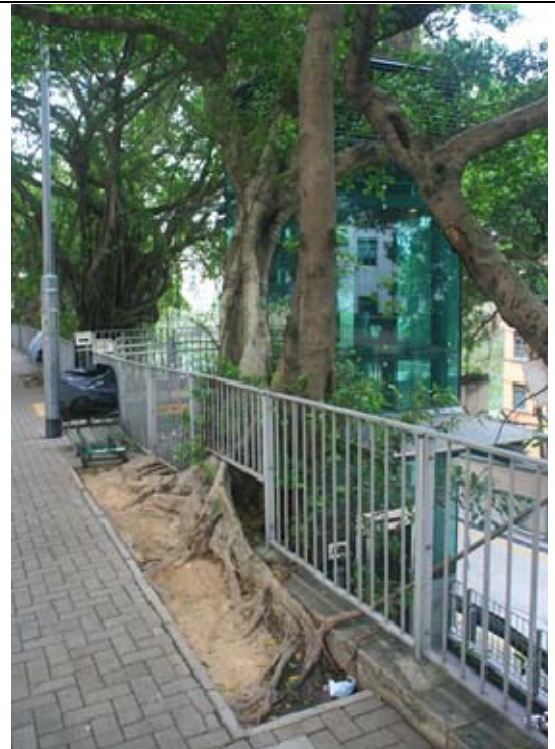
**Photo No. 7** – Provision of rooting areas at the crest of the retaining wall
