**APPENDIX 16 - Management Guidelines for Stonewall Trees**

## **Management Guidelines for Stonewall Trees**

**GREENING, LANDSCAPE AND TREE MANAGEMENT SECTION  
DEVELOPMENT BUREAU**

**December 2013**

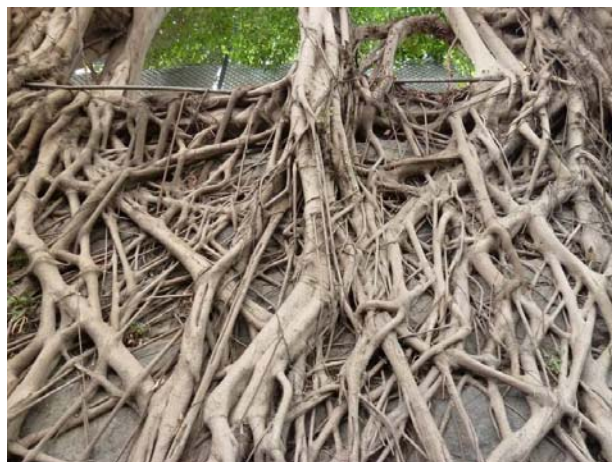
**Photo No. 1** – Distinctive root network on retaining wall surface

3.3 Roots developed on the wall surfaces also extend their colonies by sending absorbing roots to reach the soil at toe or crest of the walls to capture more water and nutrients for growth. The surface roots also fuse together at intersections to form a distinctive root network enhancing the grip on the walls. For species with aerial roots, these roots provide additional support to improve stability of stonewall trees when lignified, particularly if they can reach the soil to become prop-like supports.

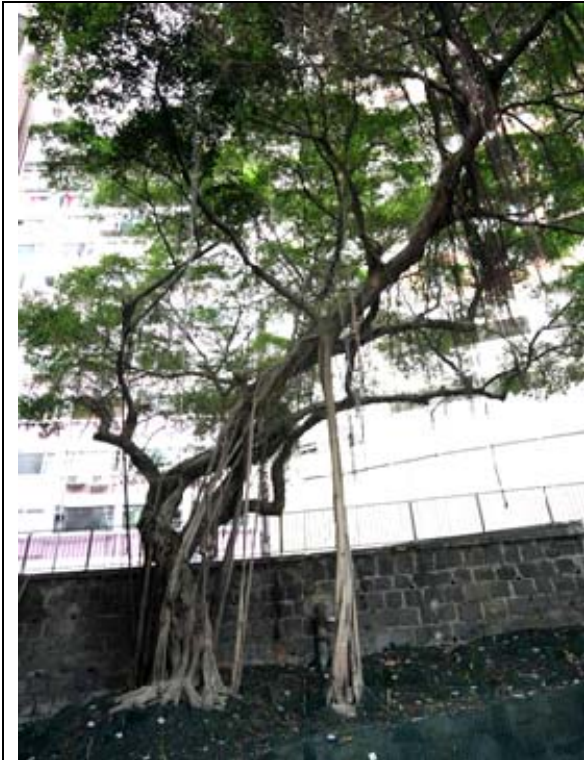
**Photo No. 2** – Lignified aerial roots forming natural prop-like supports to improve stability of stonewall tree

7.4.2 The best treatment is to allow aerial roots to reach the soil at ground to become upright lignified support for stonewall trees. If no soil is located underneath the aerial roots, opening up of paving to allow aerial roots to anchor at the ground with soil should be considered. At the same time, it would be necessary to consider the adequate strength of the whole root system to support the increased canopy size and the proportionate growth of the aerial roots to form a prop-like support. Guide tubes or ushering ropes can be used to facilitate aerial roots to reach the ground/soil quickly. If these measures are not feasible, aerial roots can be guided and ushered along branches by ropes made of degradable materials to locations for landing and anchorage. Where soil is not available in the vicinity, aerial roots can be ushered along branches to the main stems or scaffold branches to form lignified support to reinforce the branch structure. Aerial roots should be retained whenever practicable. Trimming, cutting or twisting around branches should not be allowed. Keeping joints of masonry walls unsealed is important for the root growth.

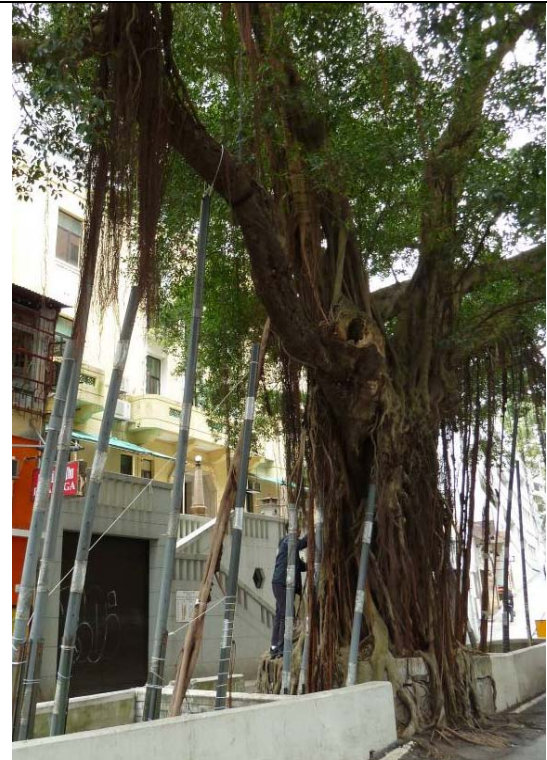
**Photo No. 3** – An example of guiding aerial roots by plastic tubes filled with planting medium

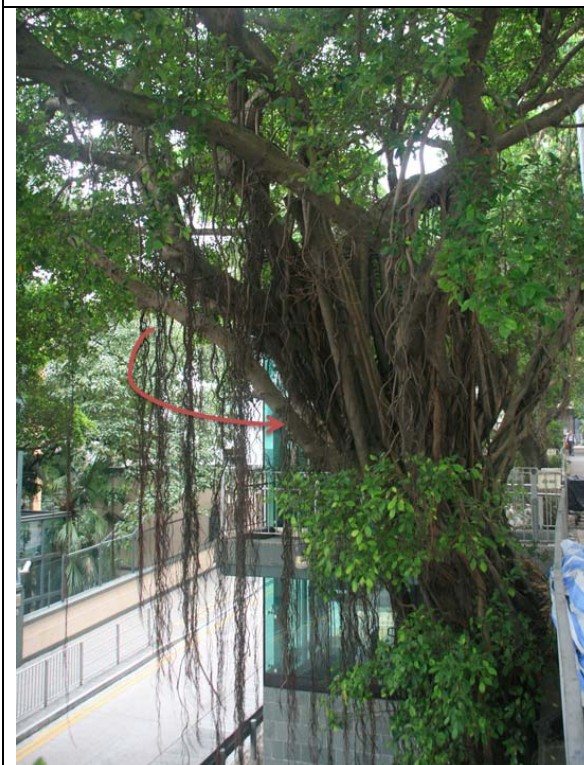
**Photo No. 4** – Aerial roots ushered along branches to the main stems or scaffold branches to form lignified support

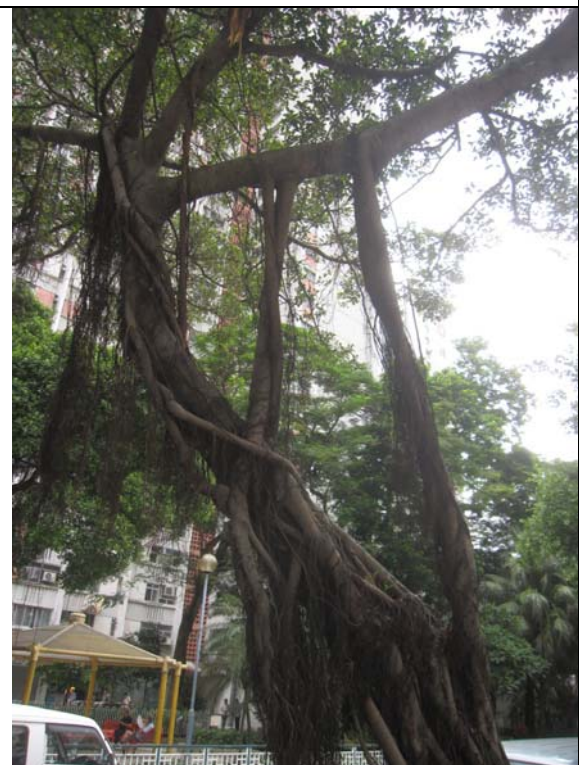
**Photo No. 5** – Aerial roots forming lignified support to strength the branch support structure

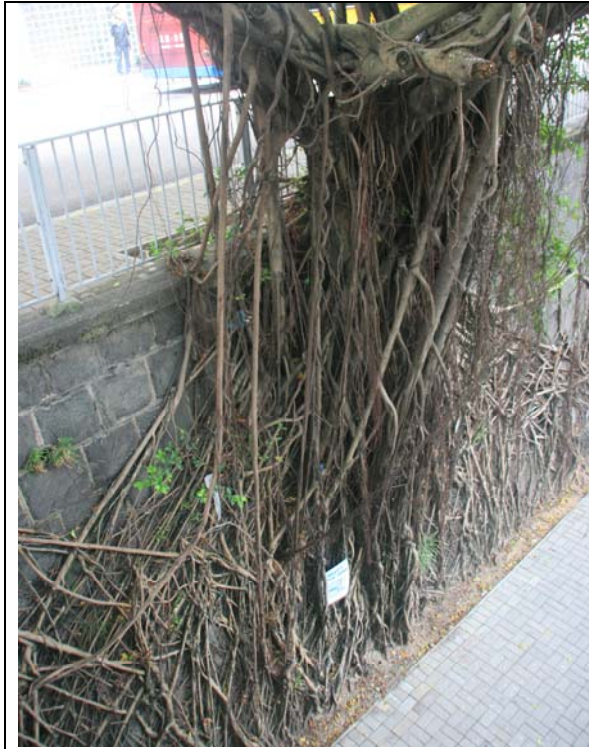
**Photo No. 6** – Provision of rooting areas at the toe of the retaining wall

Paved areas should be opened up where practicable by creating rooting areas at toe and crest of retaining walls, as it can improve water and nutrient supply and thus encourage root growth which will as a result provide extra physical support to the stonewall trees. Therefore, there should be no sealing of joints unnecessarily and in particular, at the toe of walls.

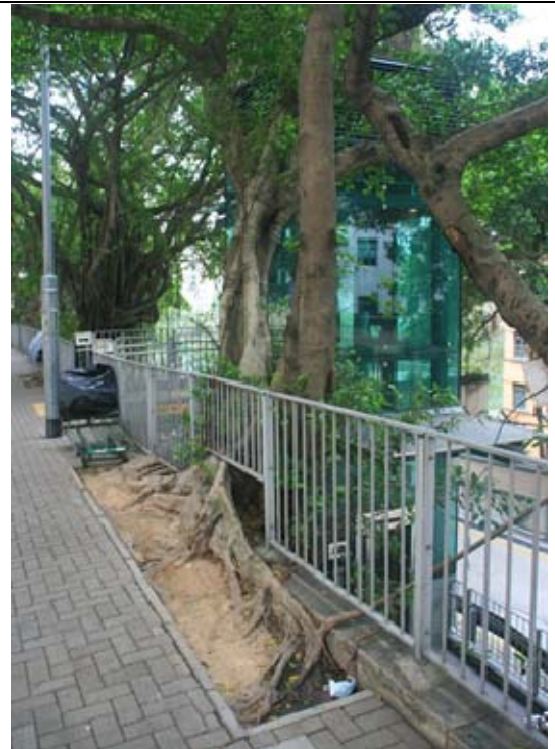
**Photo No. 7** – Provision of rooting areas at the crest of the retaining wall
